## MEMORANDUM FOR RECORD

SUBJECT: Trip Report for Pig's Eye Lake Island Construction Beneficial Use Project

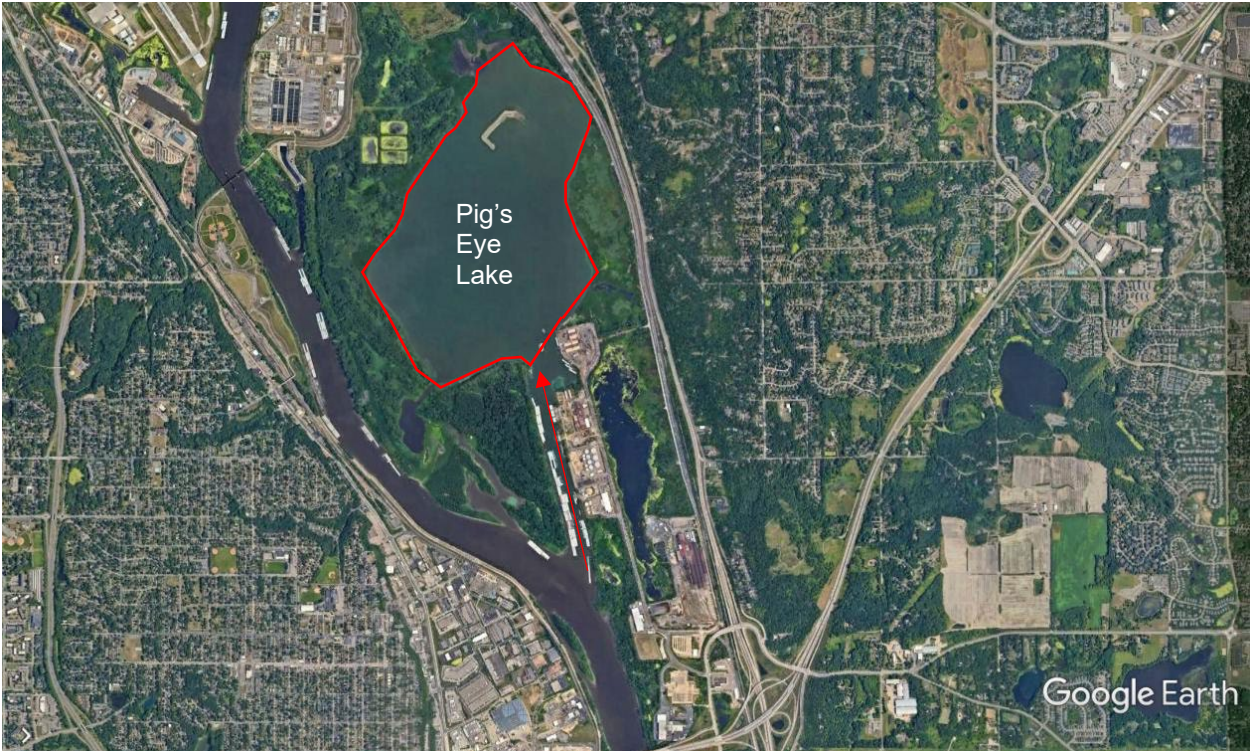
Figure 1: Pig's Eye Lake, St. Paul, Minnesota. Aerial image is from summer 2022, after island construction had begun. The red arrow indicates the connecting channel between the Mississippi River and the lake.

3. Pig's Eye Lake is a backwater area of Pool 2 (Figure 1). A small channel connects the lake to the river, and the water level in the lake fluctuates with the river stage. Under normal pool levels (the pool water level is managed at Lock and Dam 2), the lake is very shallow, only a few feet deep. Pig's Eye Lake has several identified issues including bank erosion caused by waves (although shallow, the lake has a long fetch which allows waves to develop), low levels of sediment contamination caused by urban influences on the surrounding lands, and a lack of habitat diversity caused by the uniform lakebed level and eroded shoreline. An identified solution to these issues was to construct islands of clean sediment, to form shallow areas and support native vegetation, and to function as a wave break. A total of 6 islands are being constructed. (Figure 2)

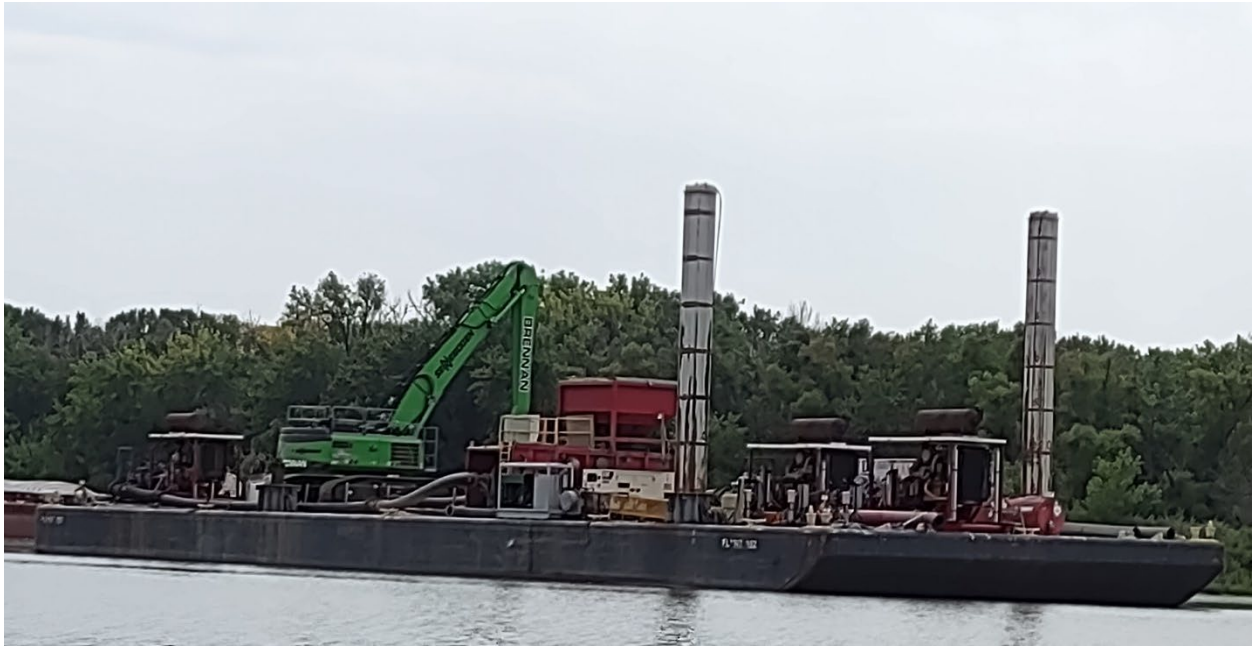
Figure 3: Brennan plant for placement. A shallow draft barge holds an excavator (green) for off-loading sediment from a barge into the red hopper. The sediment is pumped into place using hydraulic pumps.

5. Stockpiled sediment from the management site was loaded onto flatbed barges, which were transported to Pig's Eye Lake. At the lake, the material was off-loaded mechanically into a hopper that fed the sediment to pumps for hydraulic placement. (Figure 3) The sandy sediment was placed directly on the soft bottom, to elevations above the final planned grade to allow for settlement over the winter. This method worked well for the shallow lake, and a typical placement rate of 3000 CY per day

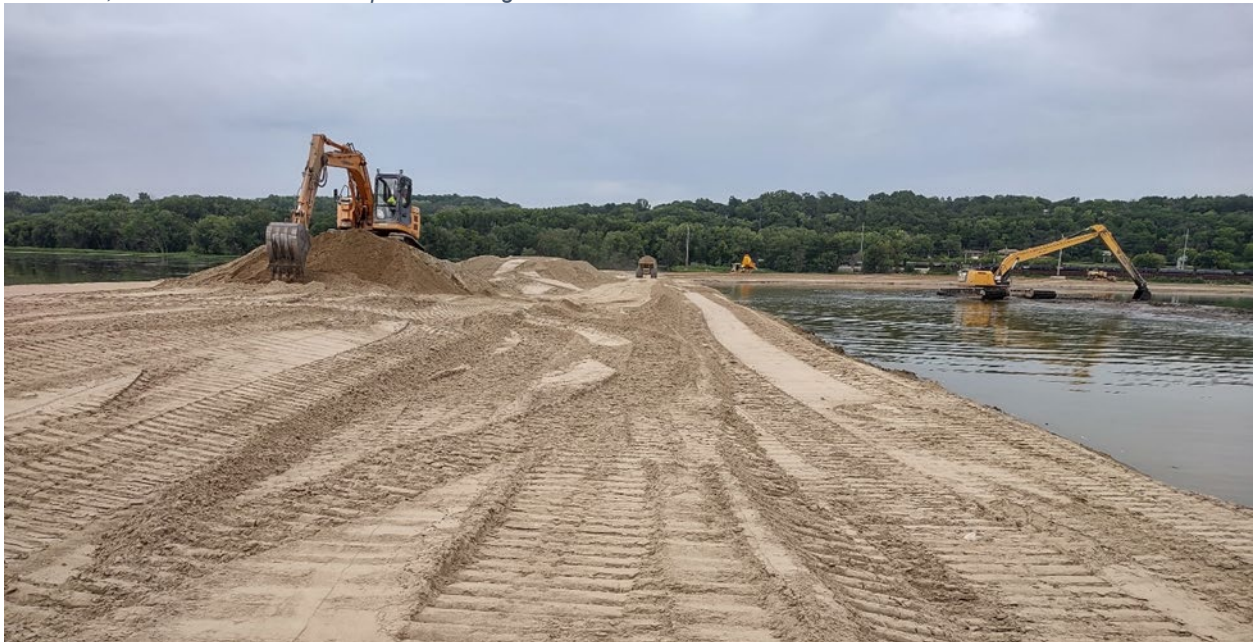
Figure 4: Earthmoving equipment is used to distribute granular material after settlement has occurred, to meet the final grade requirements. The long arm excavator on the right side of the photo is distributing sediment at the edge of the island; soft sediments were displaced during island construction.

6. The island base construction was nearly complete at the time of the site visit. Sediment placement had been completed, and the islands were being graded to a final configuration (Figure 4). (The tolerance for grading is 5", and small earthmoving equipment was being employed to meet the desired contours. Figure 5) The islands have a stepped terrain, to support various native vegetation. The next stage of the project will be to cap the granular sediment base of the islands with fine grained sediment from the navigation projects. The fine-grained material will support the plantings. It is anticipated that the top layer of sediment (12-18" of fine grained sediment over the sand base) will be placed this year, and initial planting will be completed prior to cold weather. Some planting (willows for example) will occur in the spring, due to more stringent planting windows.

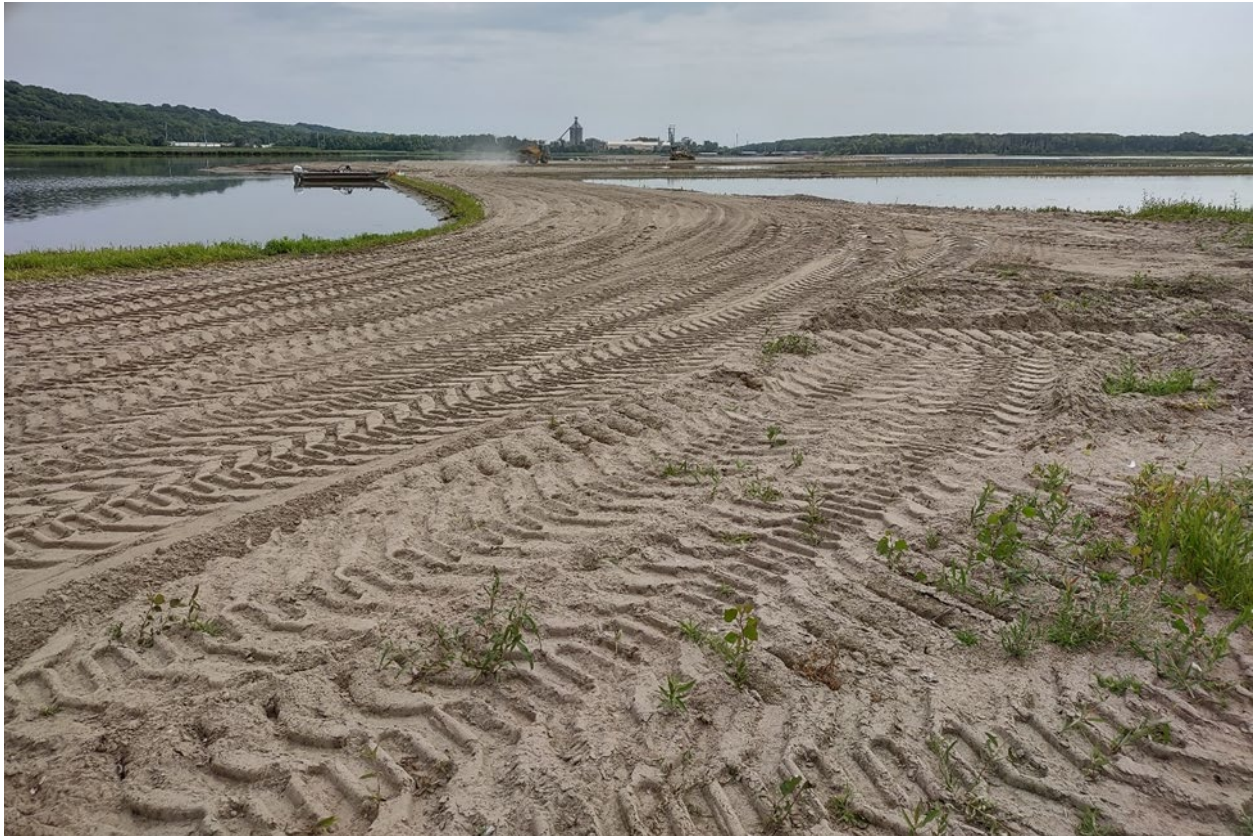
*Figure 5: Another view of the islands after grading the granular base. Volunteer vegetation has already appeared. This area will be capped with fine grained sediment that will support native plantings.*

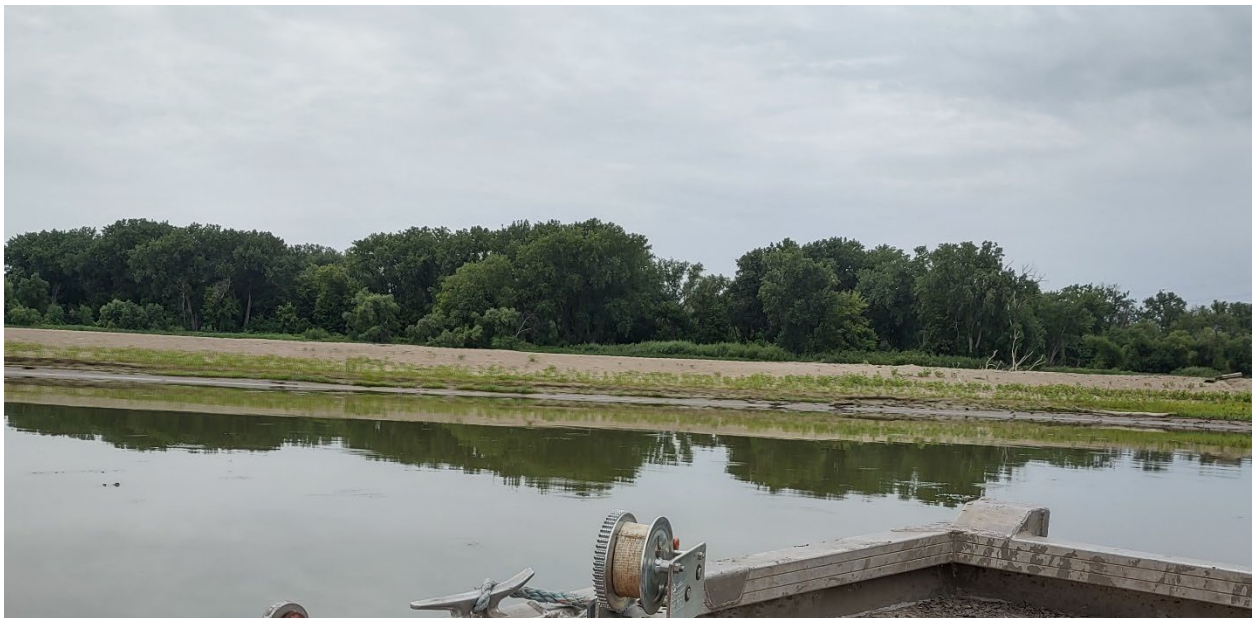
*Figure 6: Approaching one of the islands in a johnboat, vegetation and waterfowl are apparent even though island construction is not complete.*

7. Although the project is not yet complete, there is ample evidence that it is already successful from a habitat standpoint. Multiple birds, including ducks, herons, and seagulls, were actively using the islands (Figure 6, Figure 7). Volunteer vegetation was growing in many areas.

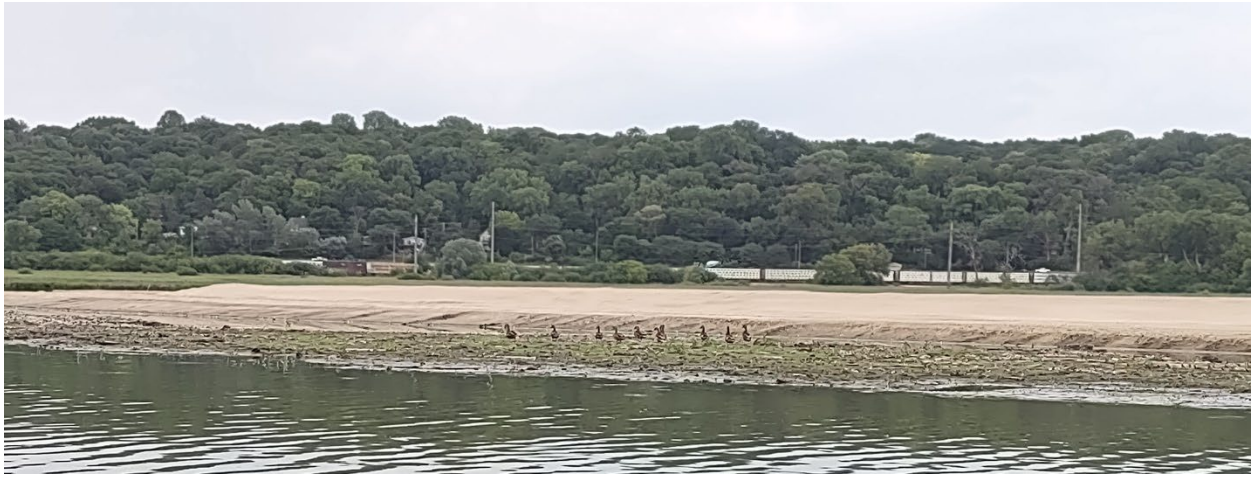
*Figure 7: Ducks on the island. Seagulls and herons were also using the islands but were less willing to be photographed.*
